Fish Stream Survey Report

Stream Name(ID) trib to stream

Road# 550

Unit# 44-42 RPQuad Map Craig C-3

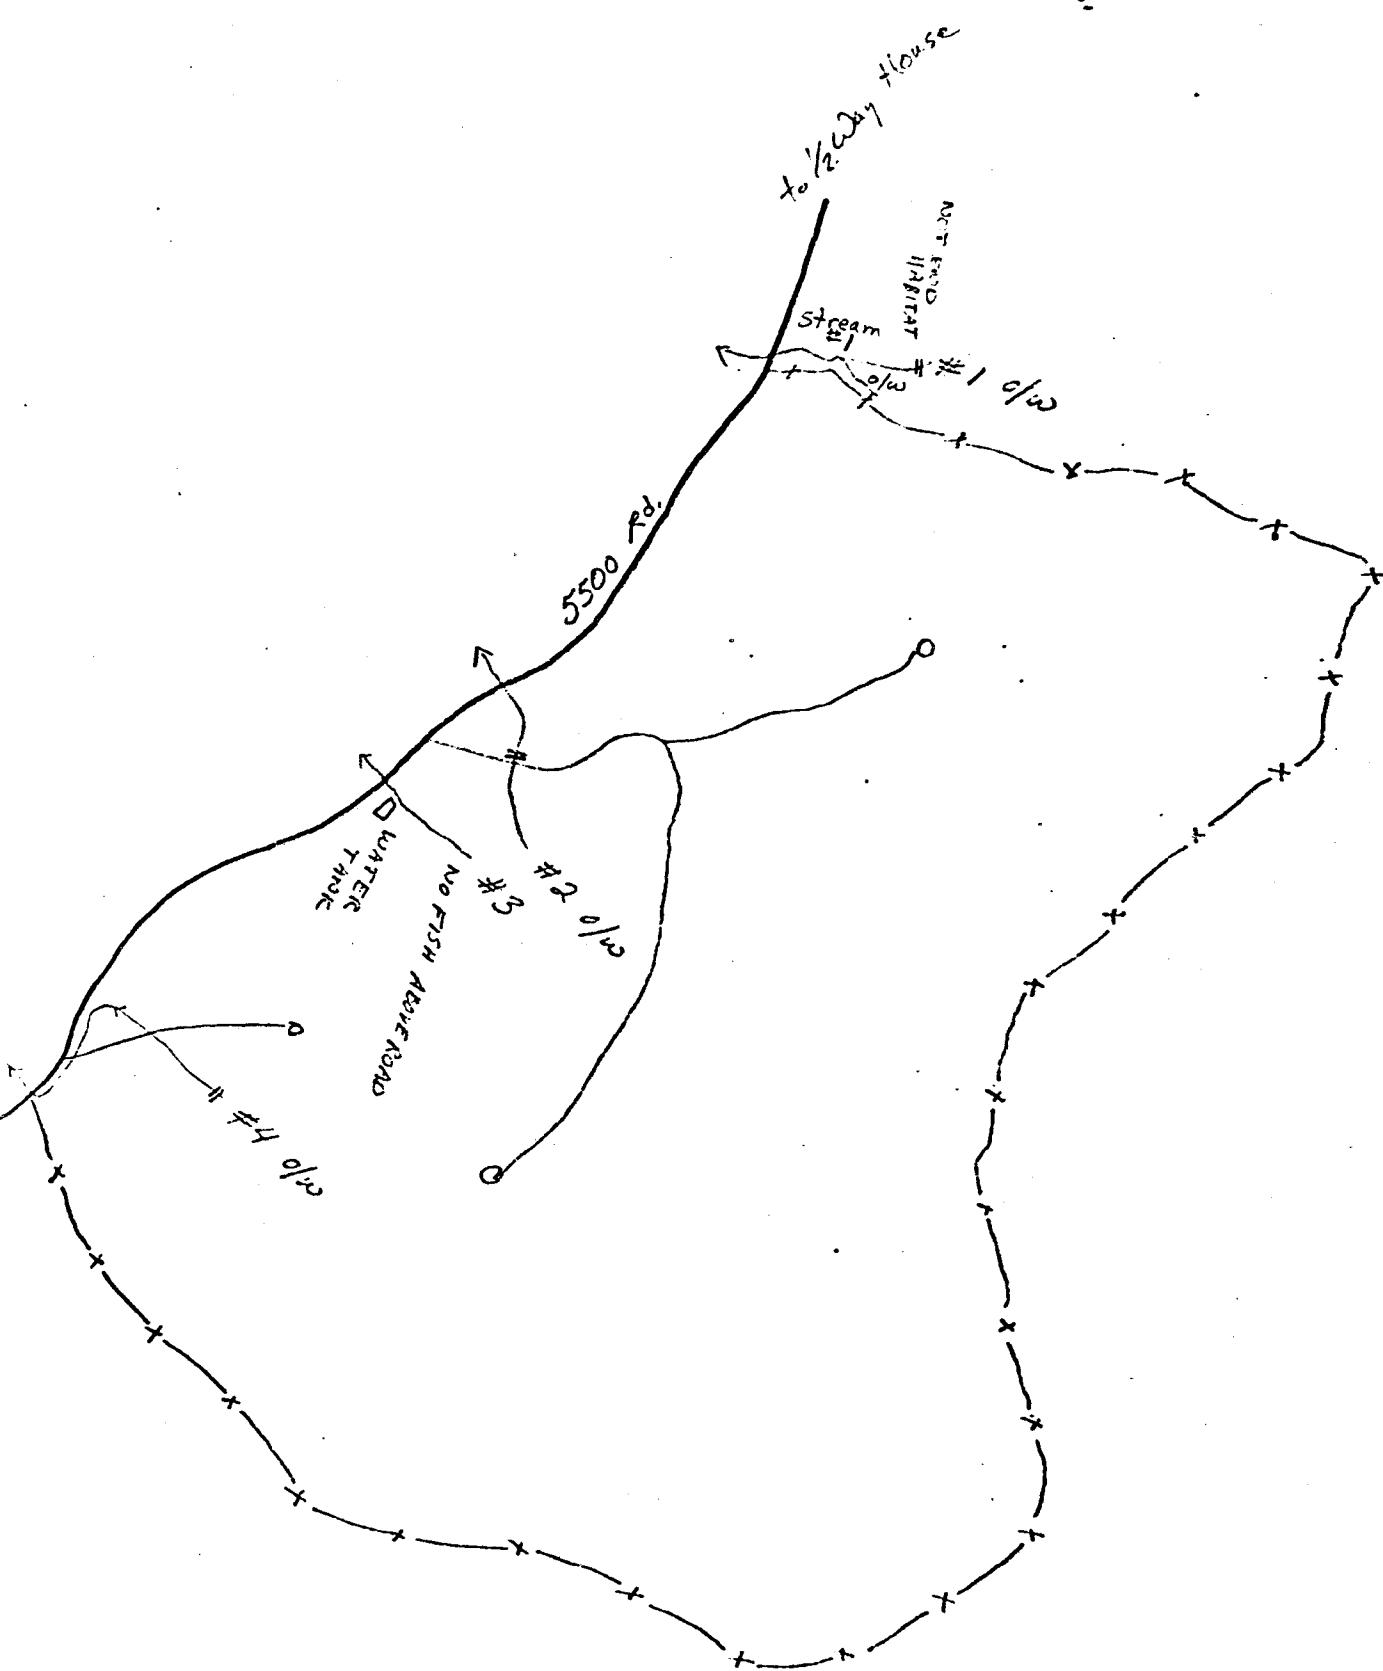
11T 44-412

STREAM #1 (Owen Creek)

This stream is 4-7 feet wide, 6-8 inches deep with 2-24 inch pools. The substrate is Bedrock/Gravel/Sand. There are excellent pools with good spawning gravel. The habitat is excellent spawning and rearing for resident populations.

The stream is flagged orange/white and crossed at the road crossing. It is double flagged but this is not the end of the habitat. The stream borders the unit boundary for several hundred feet. The CWP on the 5500 Road may need to be corrected as it has a 1.5 foot rise that may inhibit fish passage.

STREAM #2 (Morrow Cr.)

This stream is 3-4 feet wide, 3-6 inches deep, with 10-12 inch pools. The substrate is Rock/Gravel/Sand/Mud below the 5500 Road and primarily Gravel/Sand and Mud above the road crossing. The 5500 Road CHP is not passing fish adequately, however, Sea-Run Dolly Varden remains were found up stream. There is about 200 feet of habitat above the 5500 Road.

The stream is flagged Orange/white and tagged at the road. The stream was double flagged as the end of habitat where the spur road crosses. There is no fish passage required in the case of the spur road.

REACH #4 (TOM CREEK)

This stream is #2 below the 5500 Rd on the Cullough/Staples report of 10-1-79. The stream is 2-4 feet wide, 2-6 inches deep with 10-15 inch pools. There are series of small falls with pools beneath them, and the stream is excellent resident and sea run Dolly Varden spawning and rearing habitat. The substrate is Rock/Gravel/Sand with approximately 60% Gravel.

This stream is flagged orange/white for 1000-1200 feet above the road (5000) to the end of habitat. The stream is flagged at the 5500 Rd. The spur road crosses stream #4 twice. The CMP on the 5500 Road is passing spawning Sea Run Dolly Varden but there is a 12-18 inch fall and it is doubtful if it passes smaller fish.

- 1) Replace CWP on 5500 RD for fish passage (FISH BARRIER).
- 2) Directional falling or living away from stream in areas close to stream #1.
- 3) 48 hour removal of all introduced debris.
- 4) No bucking or limbing in the stream.
- 5) Full suspension REQUIRED OVER SIX.

- 1) No fish passage required on spur road, however, there is habitat before the spur road and no debris should be introduced. (SEE Recom. #4)
- 2) Only one pochlain crossing AT EACH STR. CROSSING.
- 3) directional fallings YARDING away from STREAM.
- 4) 48 hour cleanup of introduced debris.
- 5) No bucking or limbing in the stream
- 6) SPLIT ON STREAM.
- 7) ROCKING concurrent with culvert installation

Fish passage required on spur road during & after CMP Replacement on 5500 Road. FISH BARRIER construction. Only one poctain crossing AT FACTORY CROSSING
